Port Authority Facility Condition Survey Program

7 World Trade Center

April 1997

RE: Expert Professional Services for the Performance of a Condition Survey Inspection of 7 World Trade Center
P.A. Agreement #405-96-15
A&W #1584

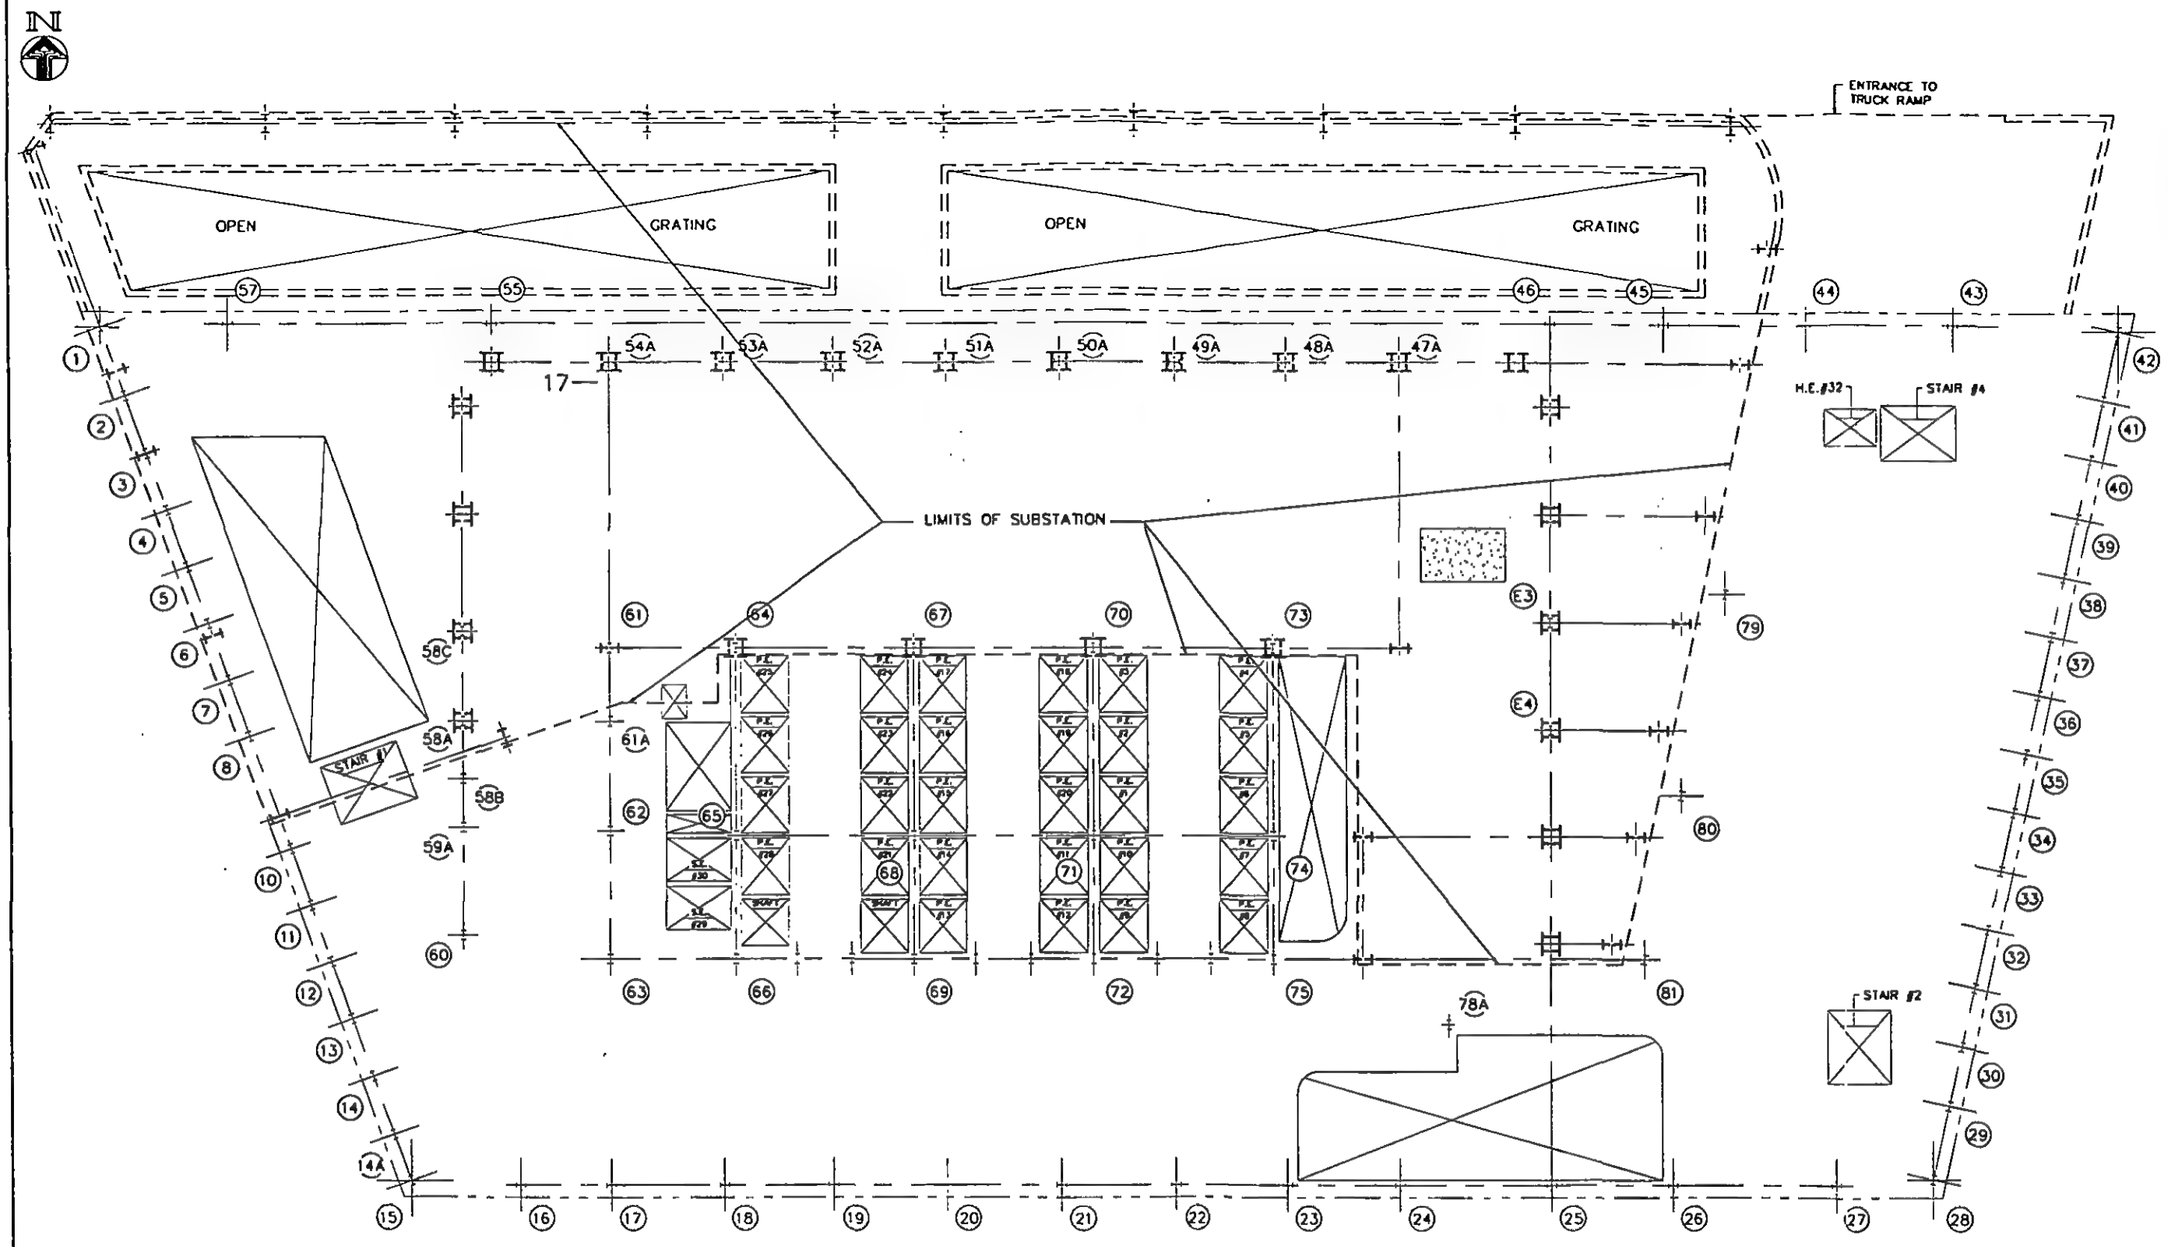
SUBSTATION PLAN
SCALE: N.T.S.

(8) — FIREPROOFING NEEDS TO BE REPLACED THROUGHOUT THE FRAMING WHERE IT HAD BEEN REMOVED FOR THE INSTALLATION OF UTILITIES AND PARTITION WALLS.

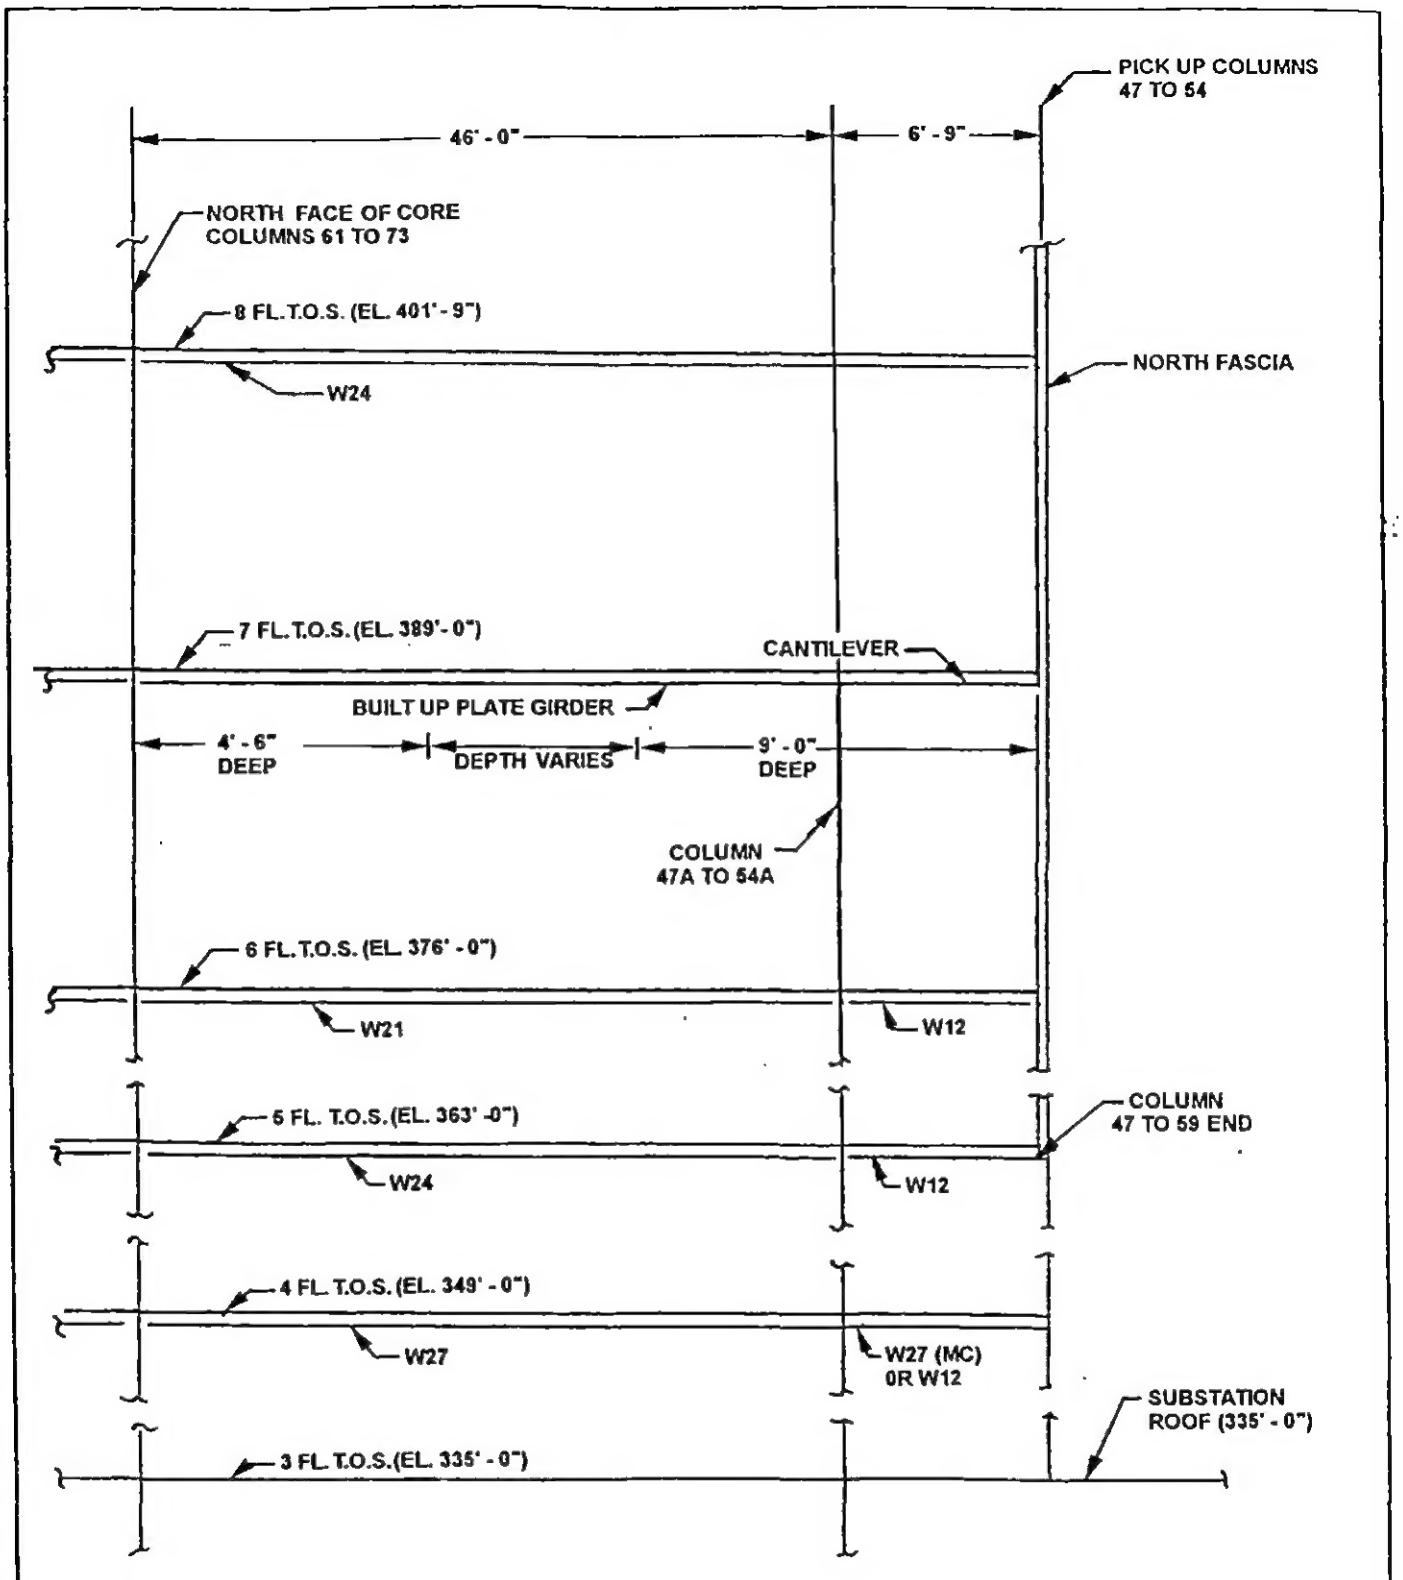
FIG. 2

The north face of the building, between columns 47 and 54 are cantilevered out over the original substation columns 47A to 54A approximately seven feet. On the 4th floor the cantilever is picked up by the moment connections to the offset Column Nos. 47A thru 54A (see Fig. 2 in Section VI). On the 7th floor are large plate girders, which span from the core columns and cantilever out over the offset columns, to the north fascia. These cantilevered girders pick up the loads from the exterior columns 47 thru 54, which support the 7th thru 47th floors (see Fig. 2 for a schematic view of this area). The load from the 5th ans 6th floor fascia columns is distributed between the cantilevered plate girders on the 7th floor and the cantilevered W27's on the 4th floor.
